NACA RM E55H12

INVESTIGATION OF A CERMET GAS-TURBINE-BLADE MATERIAL
OF TITANIUM CARBIDE INFILTRATED WITH HASTALLOY C

By Charles A. Hoffman

January 24, 1956

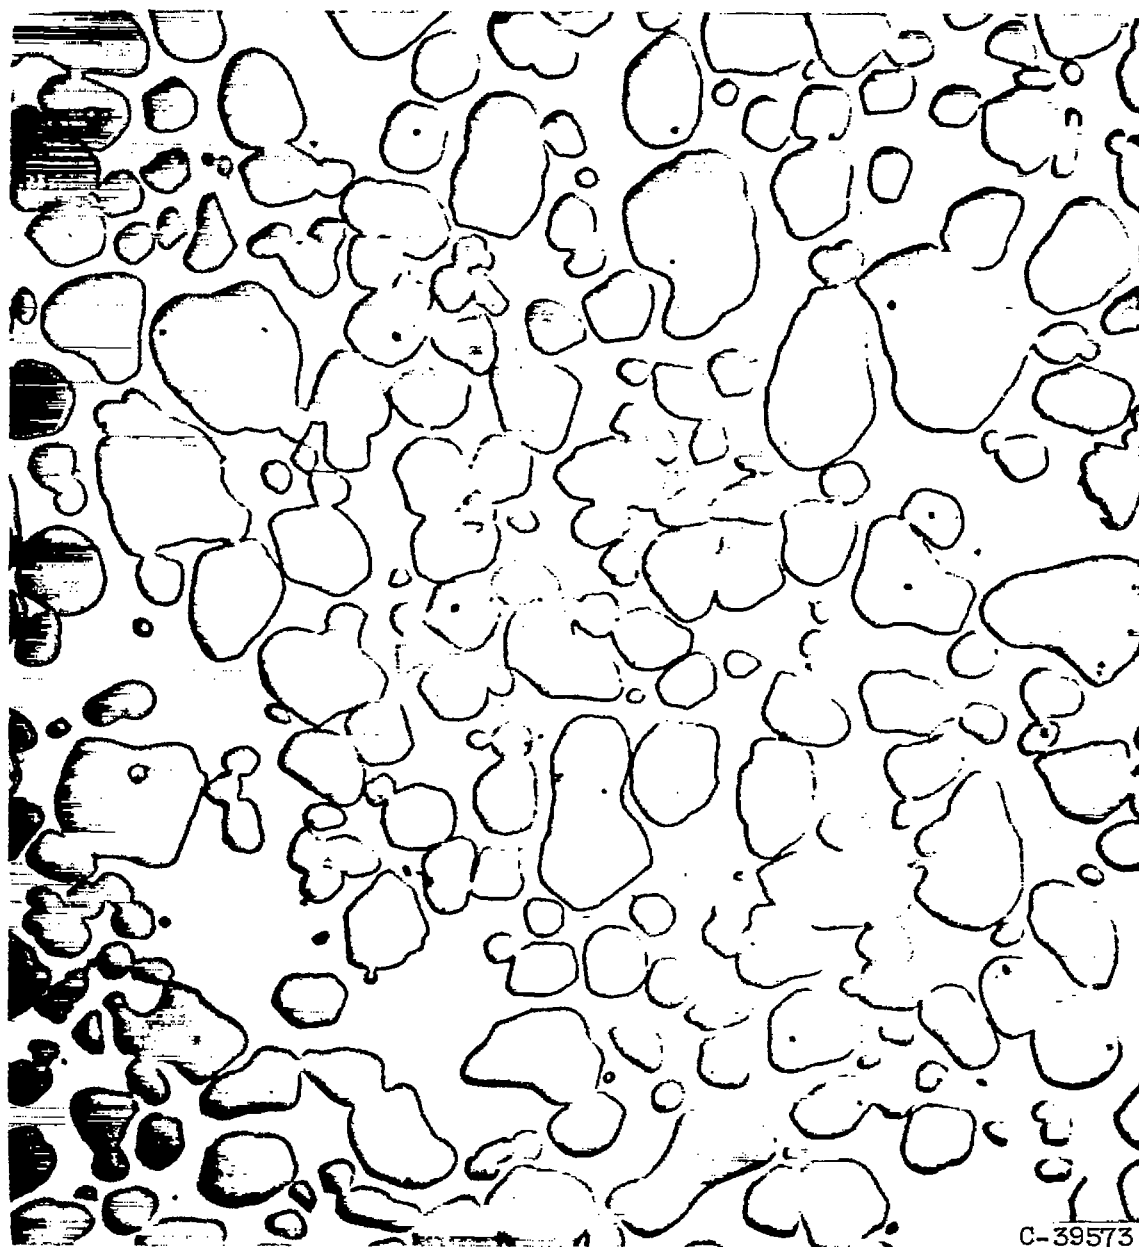
3713 The microstructure of the cermet is shown in figure 4. The metal phase appears to be continuous, and the carbide phase is rounded, that is, spheroidized. Spheroidization of the microstructure has been suggested (ref. 6) as a method of imparting ductility to an otherwise brittle cermet. While the effect of structure on ductility has not been definitely established, reference 1 reports that an infiltrated cermet had higher impact strength than cold-pressed and sintered cermets of other compositions; the improvement is attributed to rounding of the carbide particles and to more even distribution of the carbides in the metal phase. The observed structure might also explain why blades of the present material appeared to be comparatively free of sensitivity to stress concentration, which will be discussed subsequently.

Figure 4. - Titanium carbide infiltrated with Hastalloy C. Unetched; X1000.

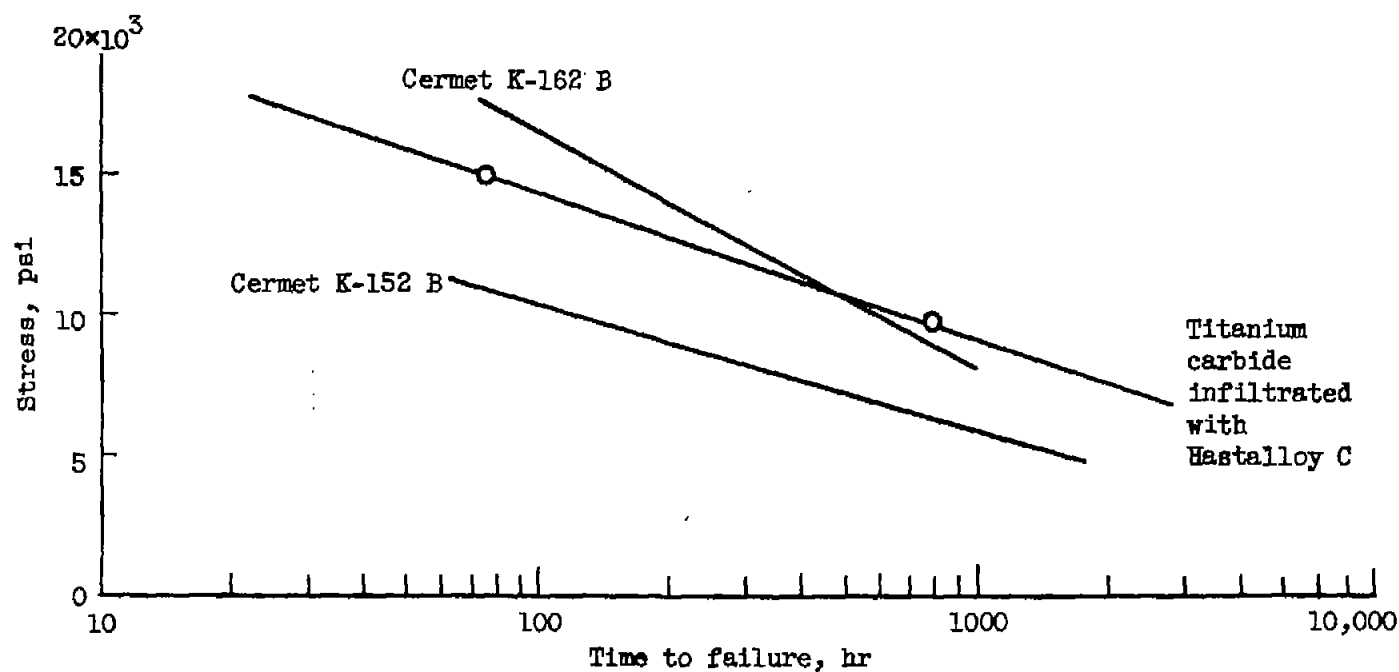
(a) 1800° F.

Results of the stress-rupture study are presented in figure 5. Failure of the cermet specimens generally occurred at the fillet between the conical portion and the cylindrical portion. This location of failure indicates that the observed stress-rupture values are lower than they might have been if failure had occurred toward the center of the specimen. The reason that failure occurred at the fillet is not clear. The occurrence of stress concentration effects in the tensile specimens is inconsistent with the blade results. Although two of the specimens showed severe oxidation (perhaps due to segregation) in small areas of the test bars, the remainder of the specimens were not appreciably attacked in the temperature range of 1600° to 1800° F.

Stress-rupture data at 1800° F for the test cermet are presented in figure 5(a); data for two other currently interesting materials are included to indicate the relative strength of this composition. Despite the higher metal content of the test cermet (50 percent by weight compared with 30 percent by weight for the other compositions), the strengths of the three materials were quite similar.

Figure 5. - Comparative stress-rupture strengths.

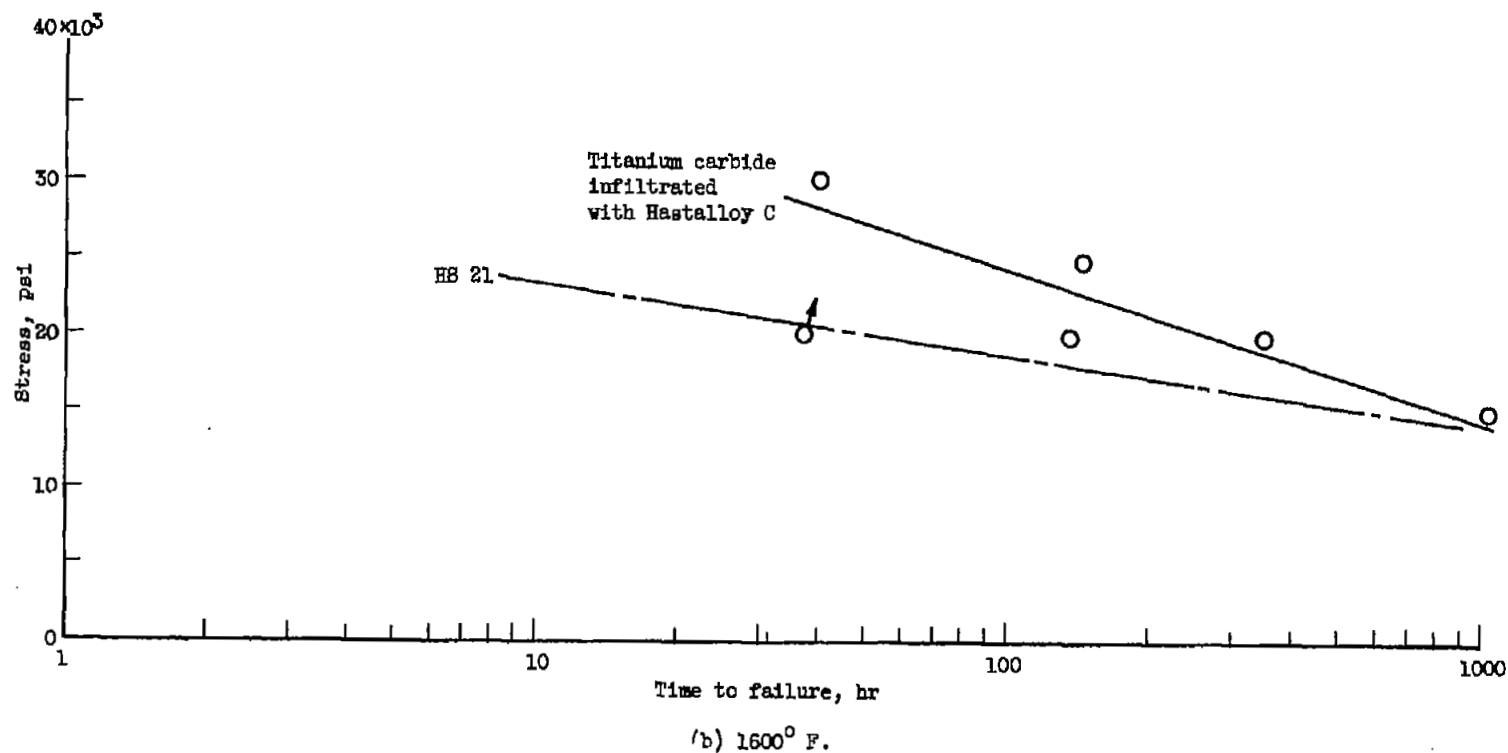
The 1600° F stress-rupture strengths for the infiltrated cermet and for the HS-21 control alloy are presented in figure 5(b). On the basis of these data alone, blades of the cermet would be expected to have longer lives than blades of this alloy.

Figure 5. - Concluded. Comparative stress-rupture strengths.
